NAVAL POSTGRADUATE SCHOOL

THESIS

**CORROSION AND THERMAL PROCESSING IN COLD
GAS DYNAMIC SPRAY DEPOSITED AUSTENITIC
STAINLESS STEEL COATINGS**

June 2016

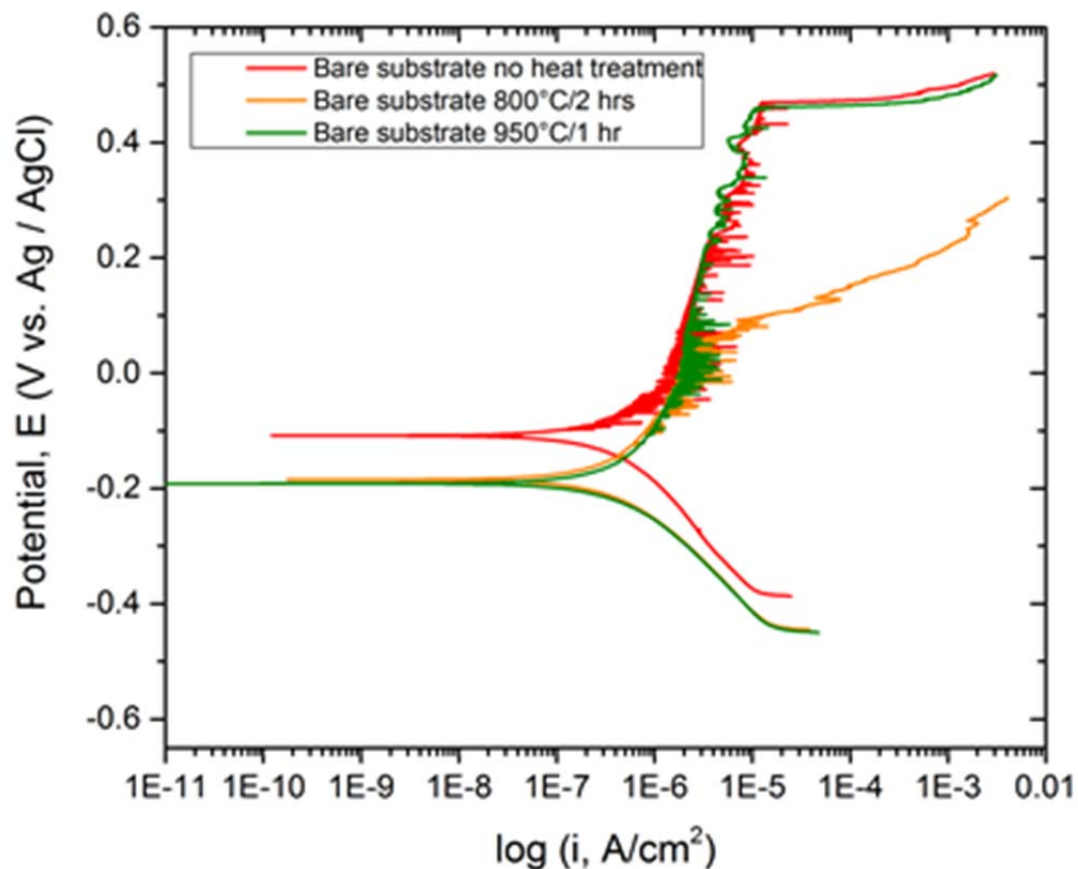
Figure 56. Polarization curves for bulk 316L substrates.

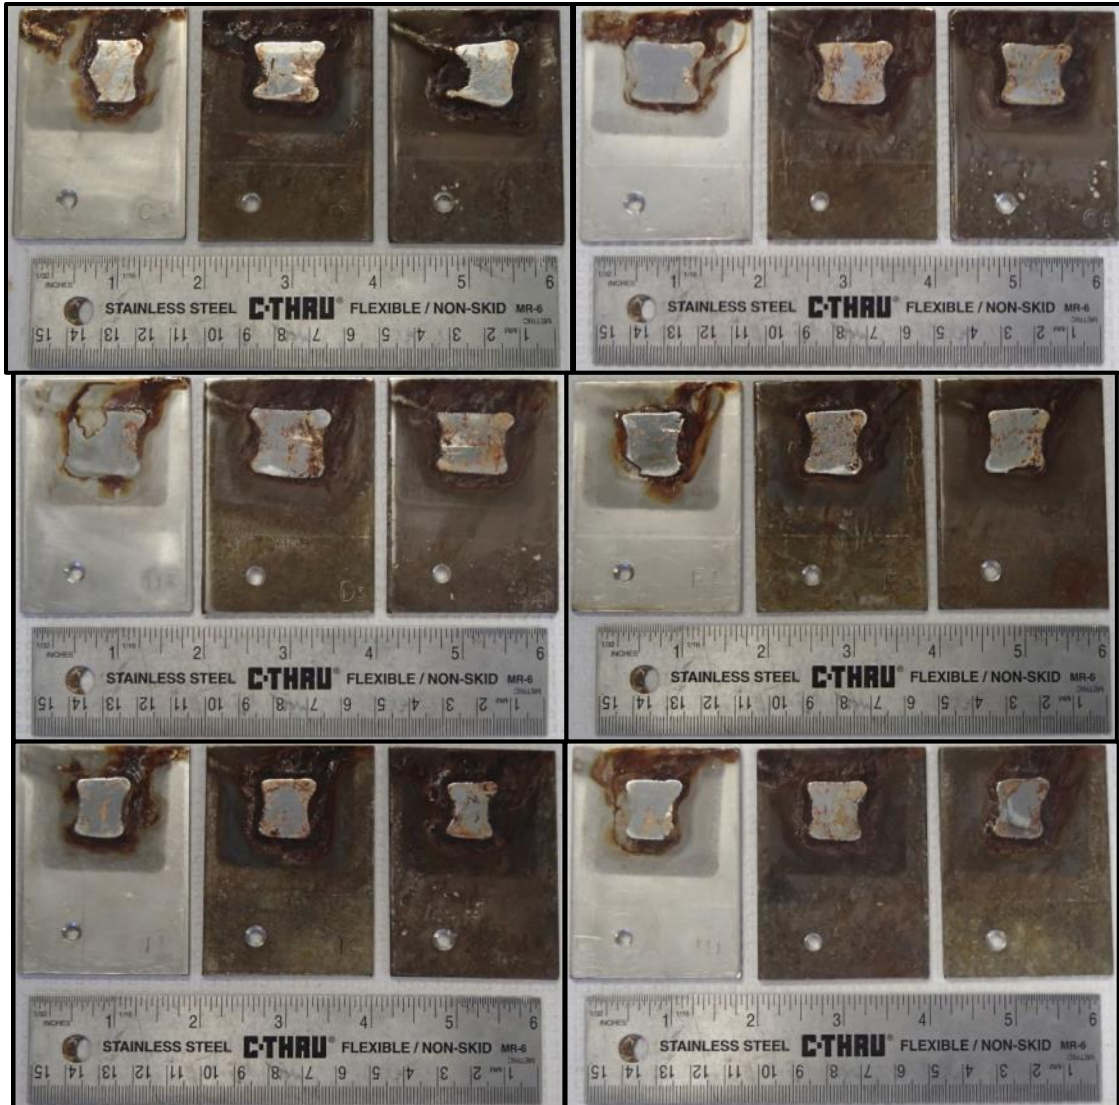
Figure 57. Photographs of samples following 1000 hours salt fog chamber exposure and cleaning with deionized water/methanol showing evidence of corrosion on coating sides. Top 5001; middle 5002; bottom PG-AMP-10.

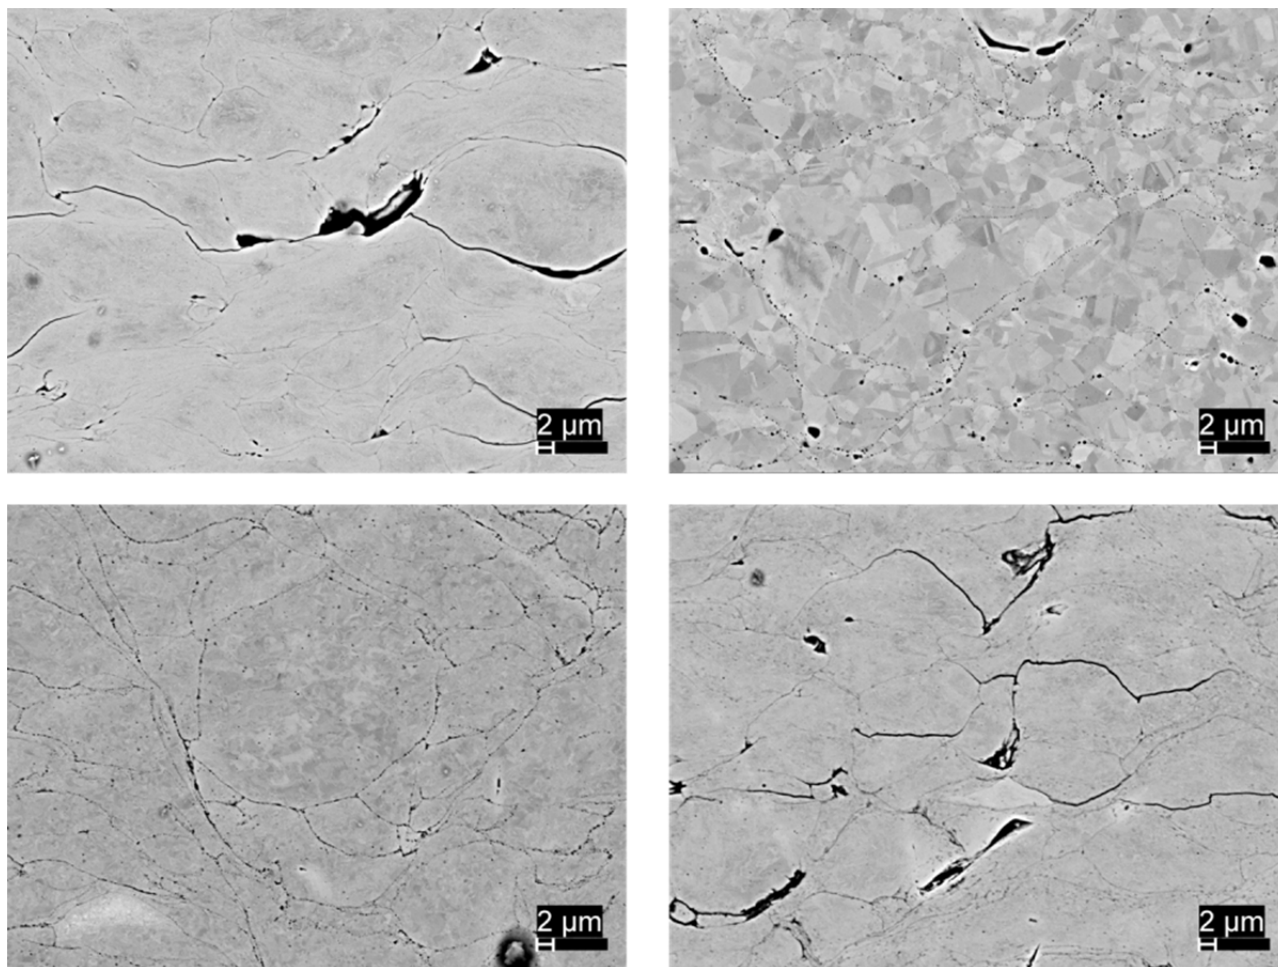
Figure 60. Low resolution SEM micrographs of 5001 coating, backscatter mode: As sprayed (top left); 950°C/1 hr (top right); 800°C/2 hrs (bottom left); 600°C/8 hrs (bottom right).

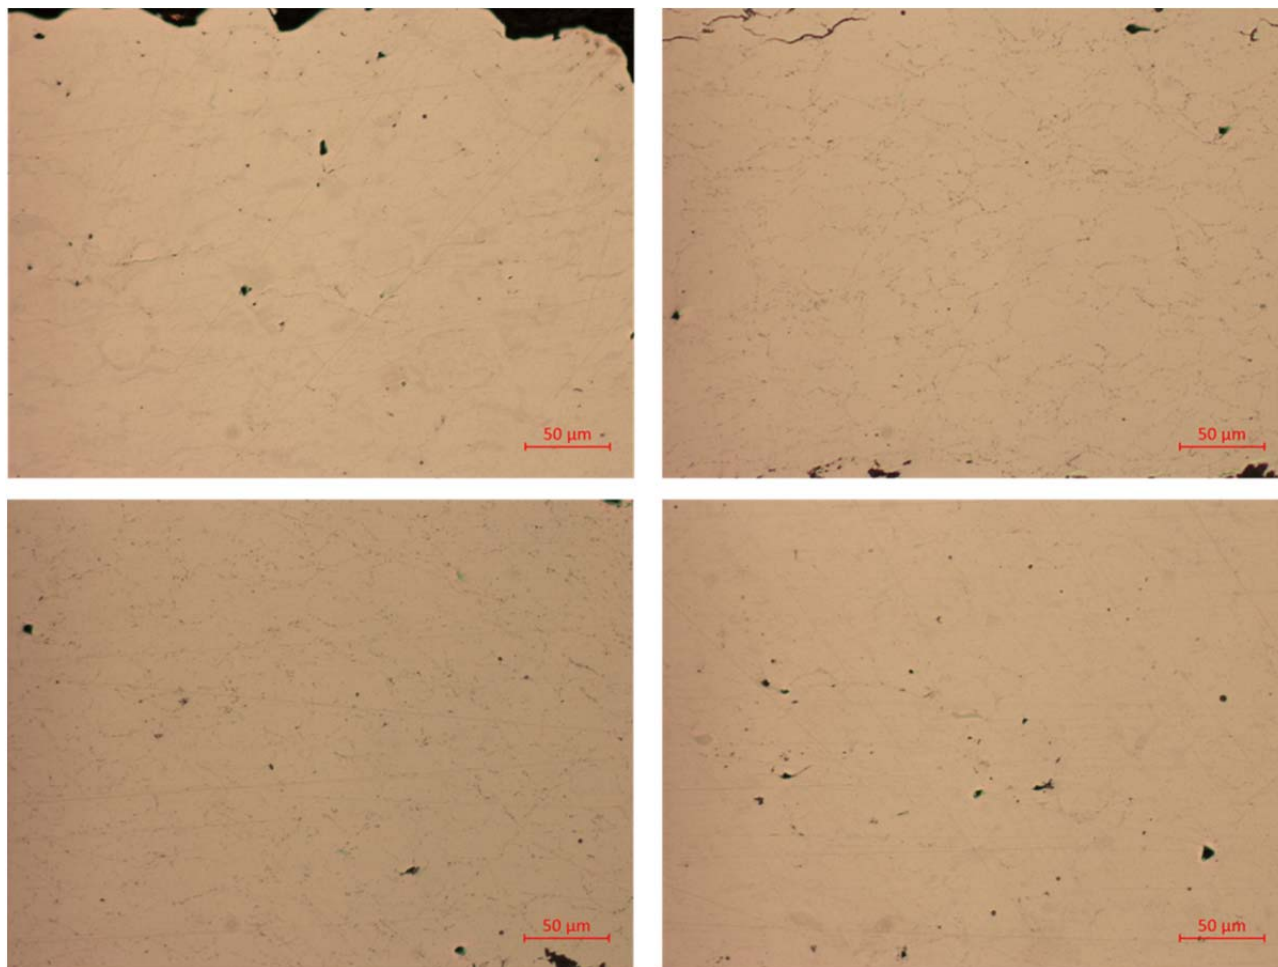
Figure 63. High resolution optical micrographs of 5002 coating: As sprayed (top left); 950°C/1 hr (top right); 800°C/2 hrs (bottom left); 600°C/8 hrs (bottom right).

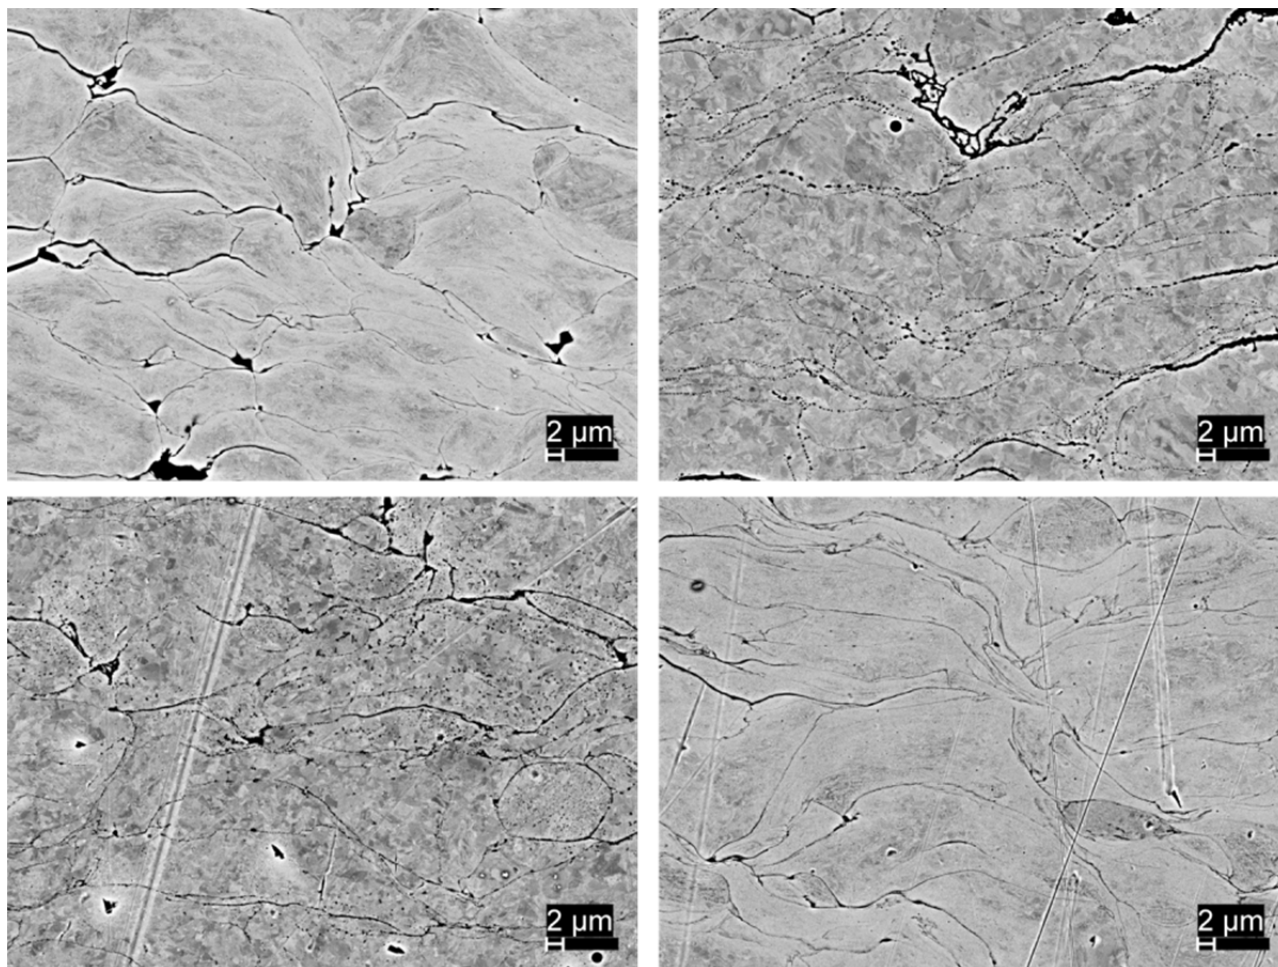
Figure 64. Low resolution SEM micrographs of 5002 coating, backscatter mode: As sprayed (top left); 950°C/1 hr (top right); 800°C/2 hrs (bottom left); 600°C/8 hrs (bottom right).

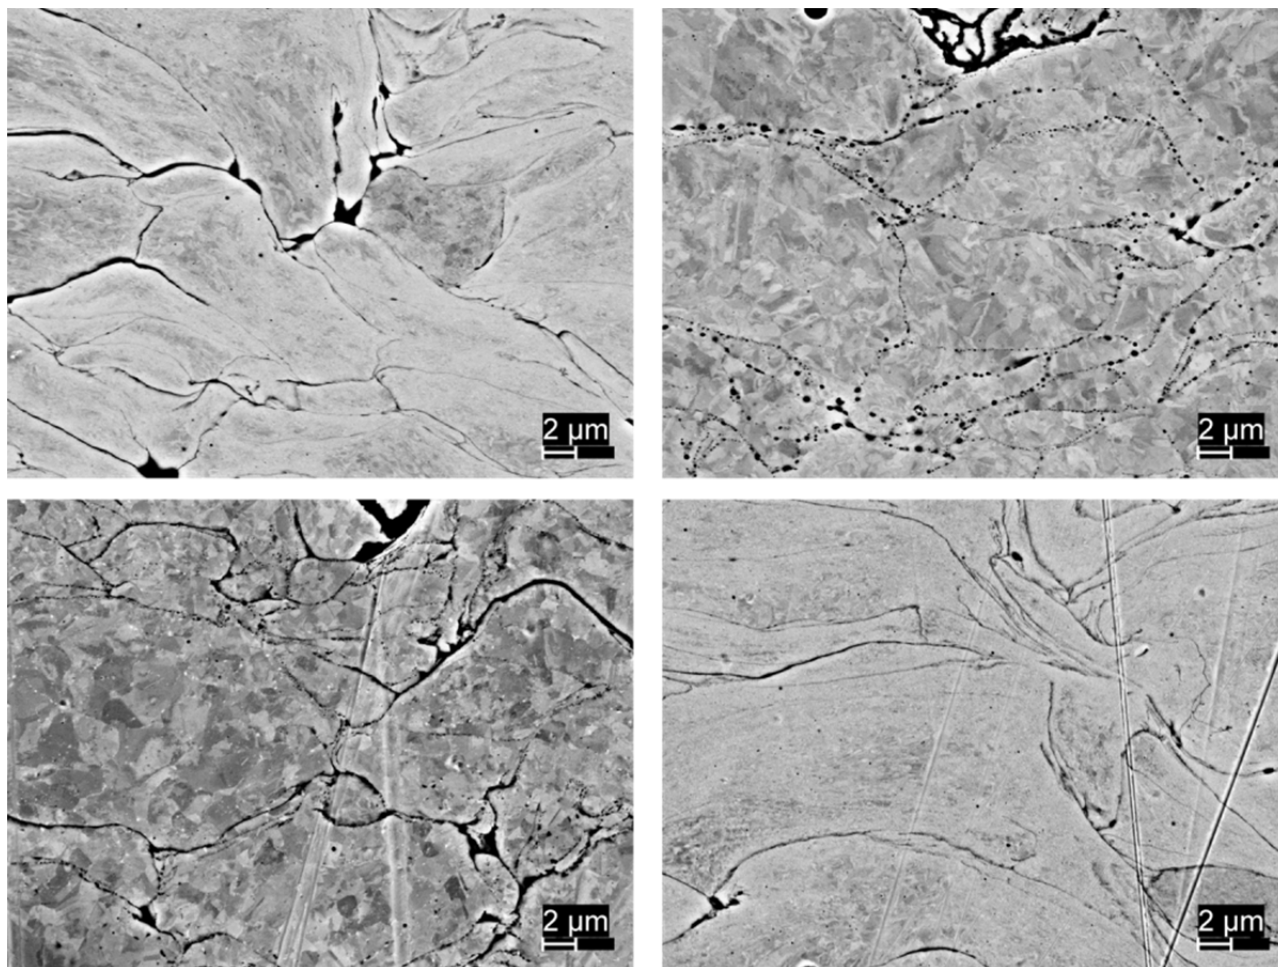
Figure 65. High resolution SEM micrographs of 5002 coating, backscatter mode: As sprayed (top left); 950°C/1 hr (top right); 800°C/2 hrs (bottom left); 600°C/8 hrs (bottom right).

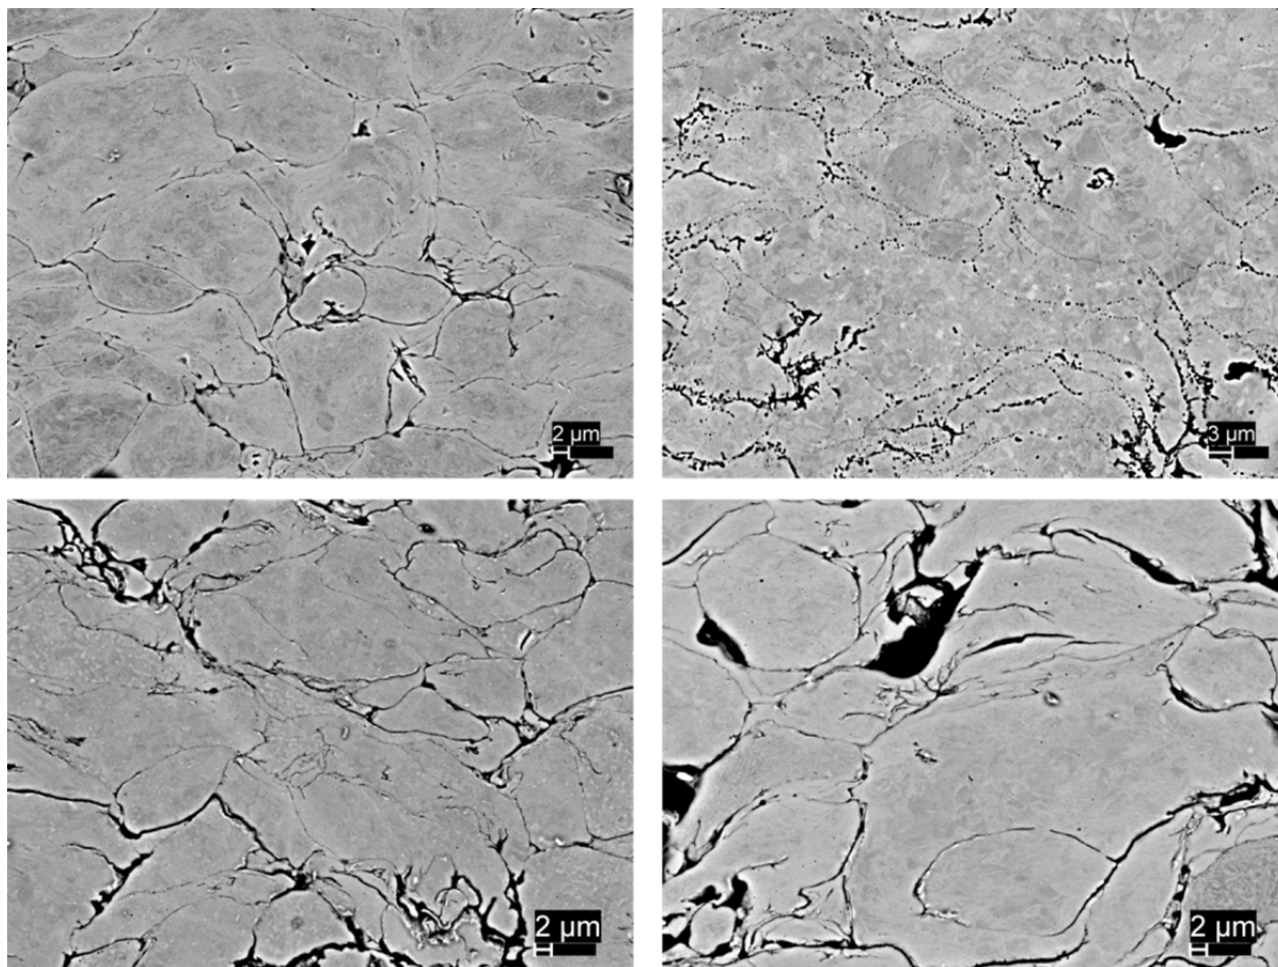
Figure 68. Low resolution SEM micrographs of PG-AMP-10 coating, backscatter mode: As sprayed (top left); 950°C/1 hr (top right); 800°C/2 hrs (bottom left); 600°C/8 hrs (bottom right).

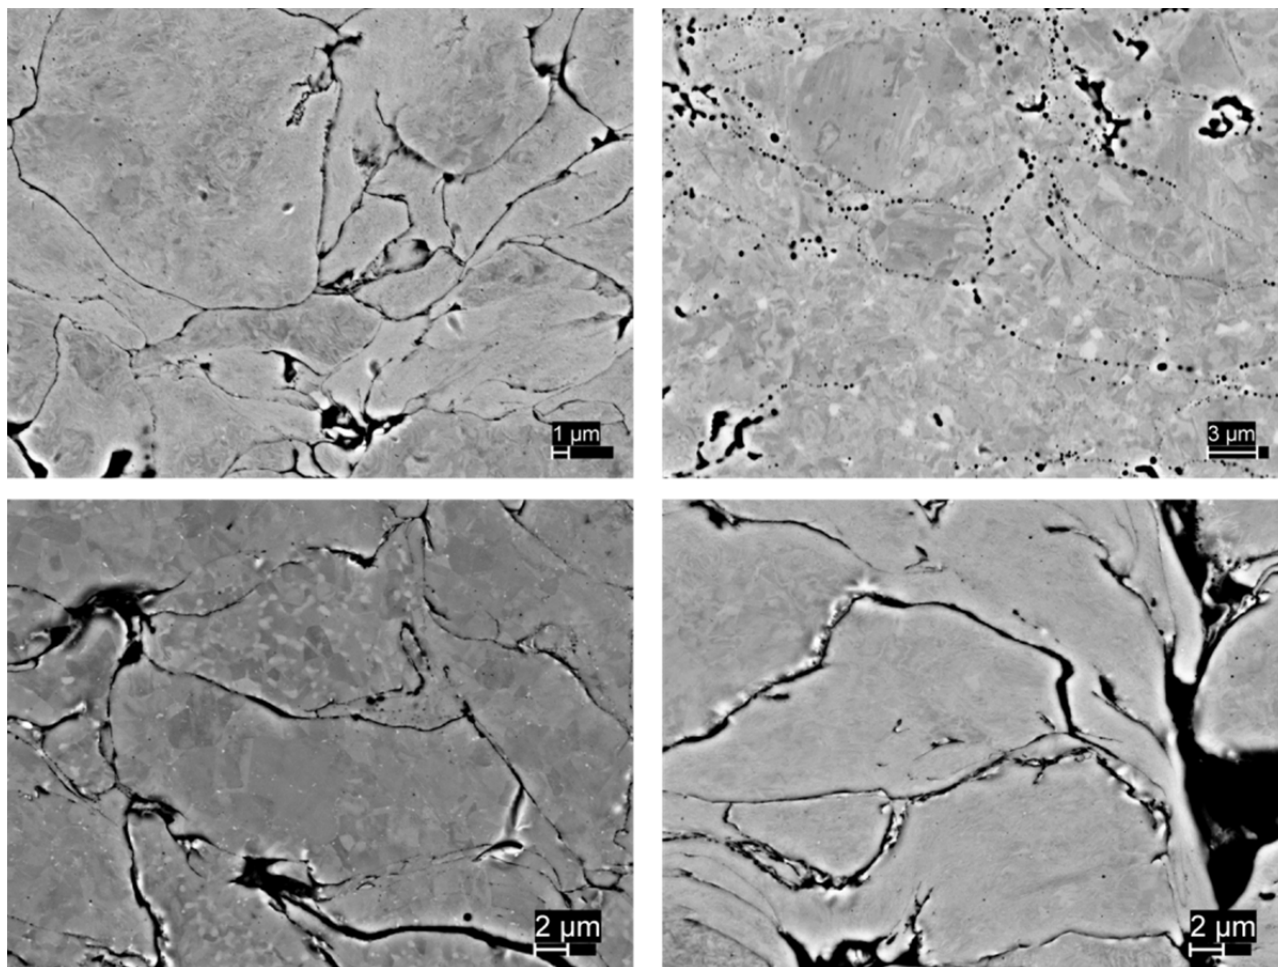
Figure 69. High resolution SEM micrographs of PG-AMP-10 coating, backscatter mode: As sprayed (top left); 950°C/1 hr (top right); 800°C/2 hrs (bottom left); 600°C/8 hrs (bottom right).

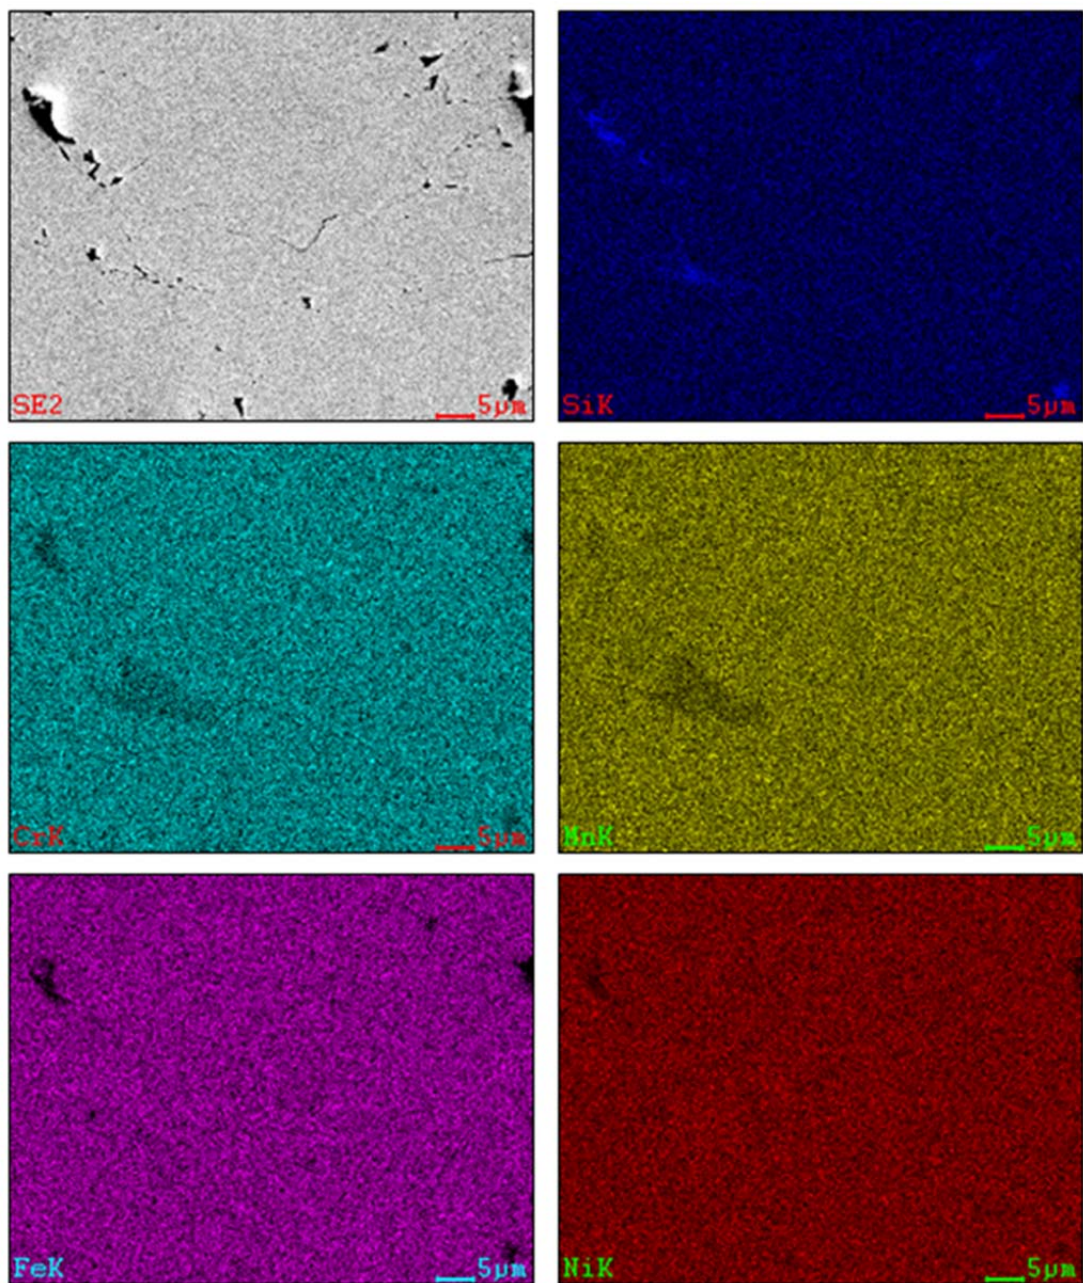
Figure 70. EDS Maps of 5001 powder as sprayed.

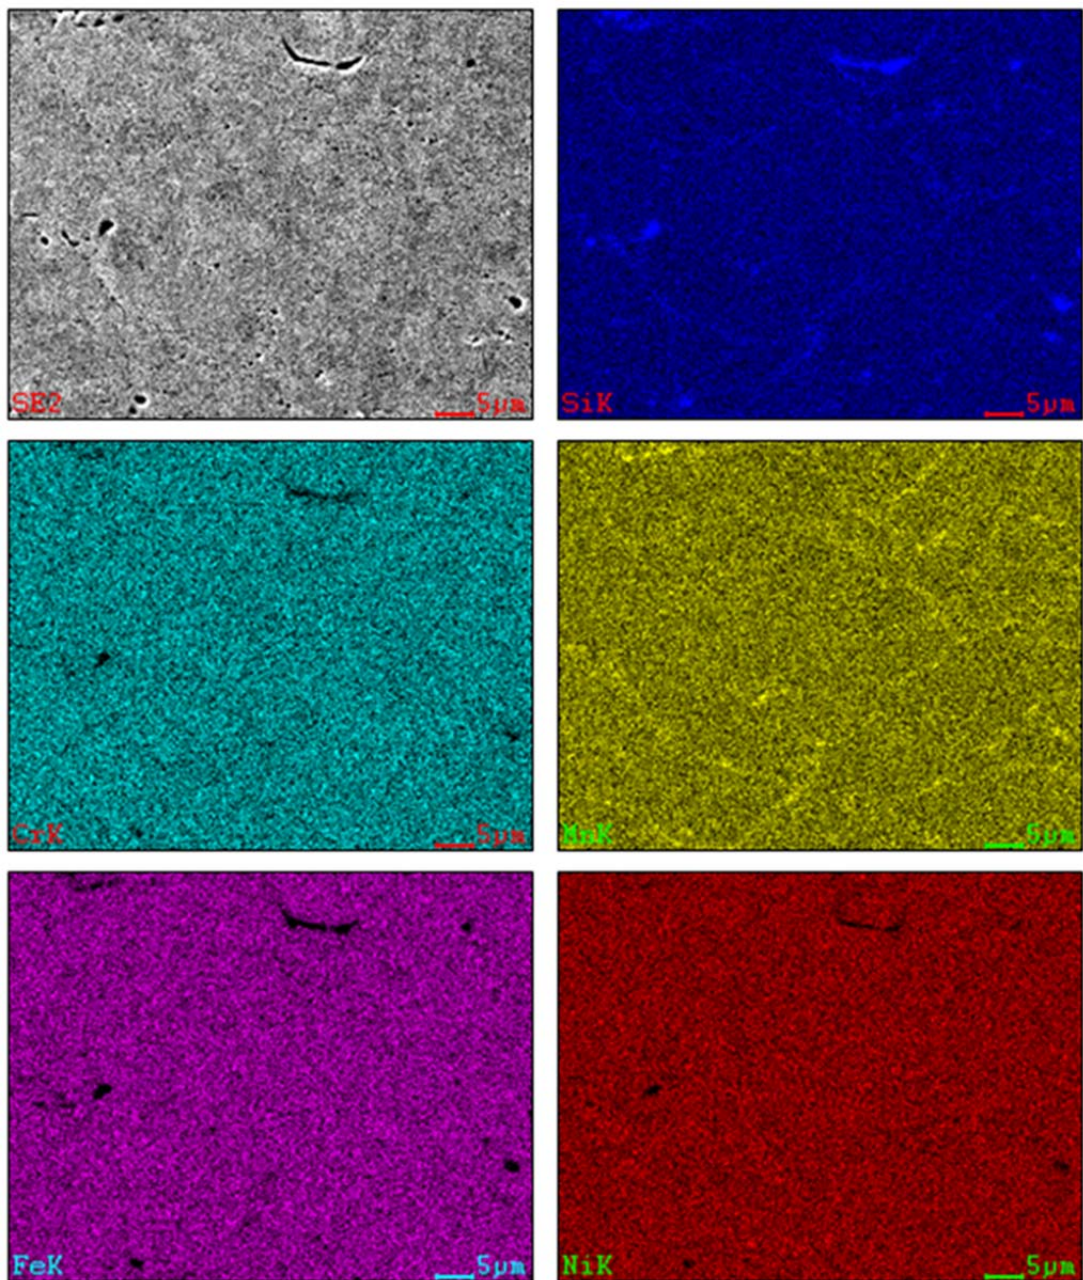
Figure 71. EDS Maps of 5001 powder, 950°C/1 hr heat treatment.

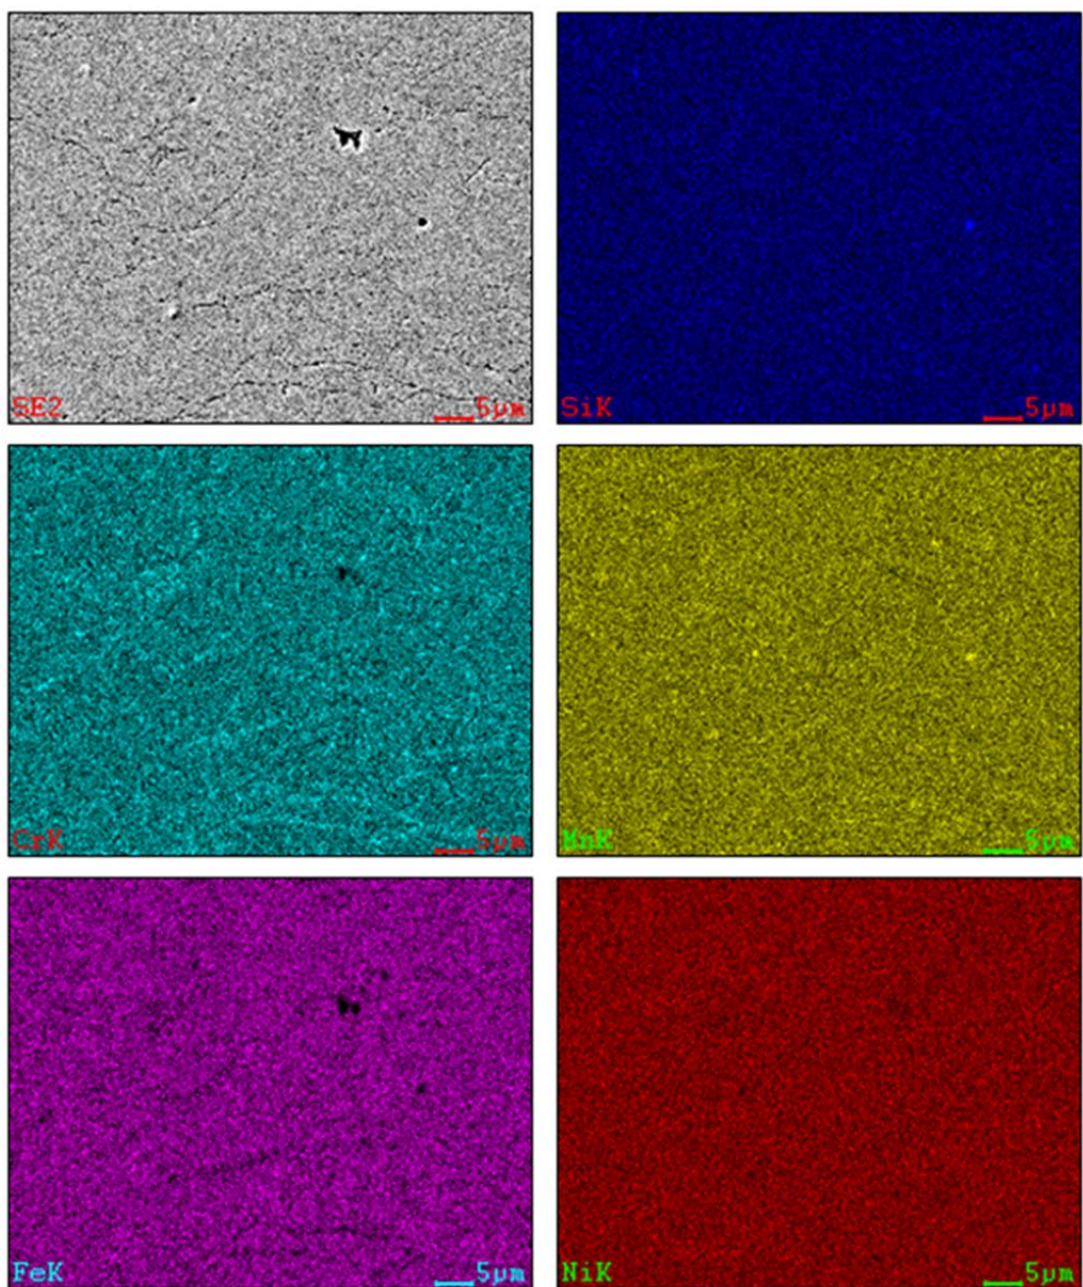
Figure 72. EDS Maps of 5001 powder, 800°C/2 hrs heat treatment.

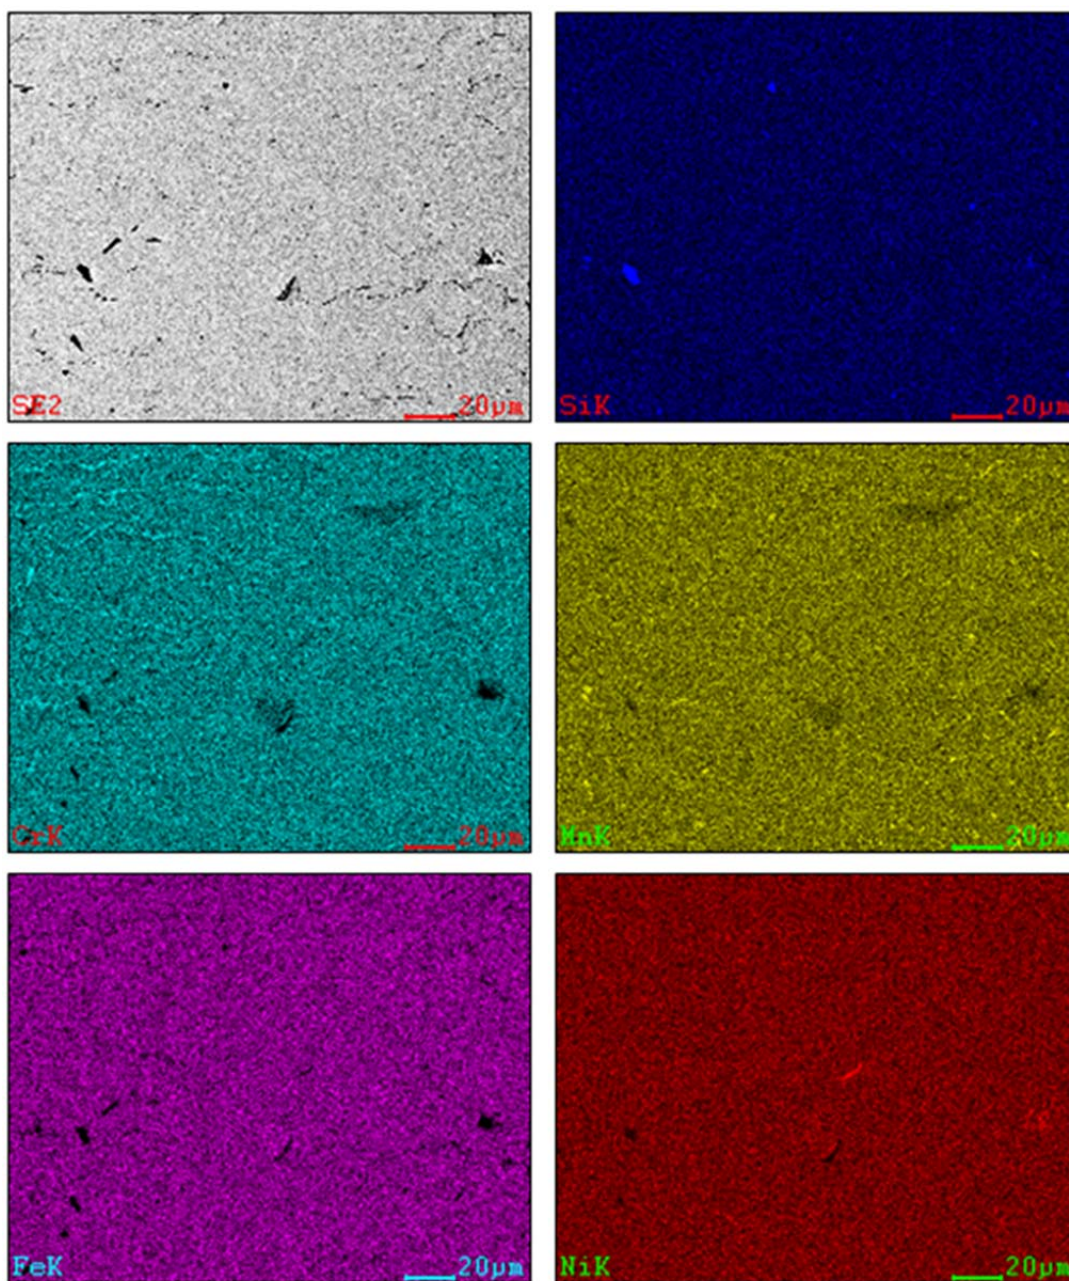
Figure 73. EDS Maps of 5001 powder, 600°C/8 hrs heat treatment.

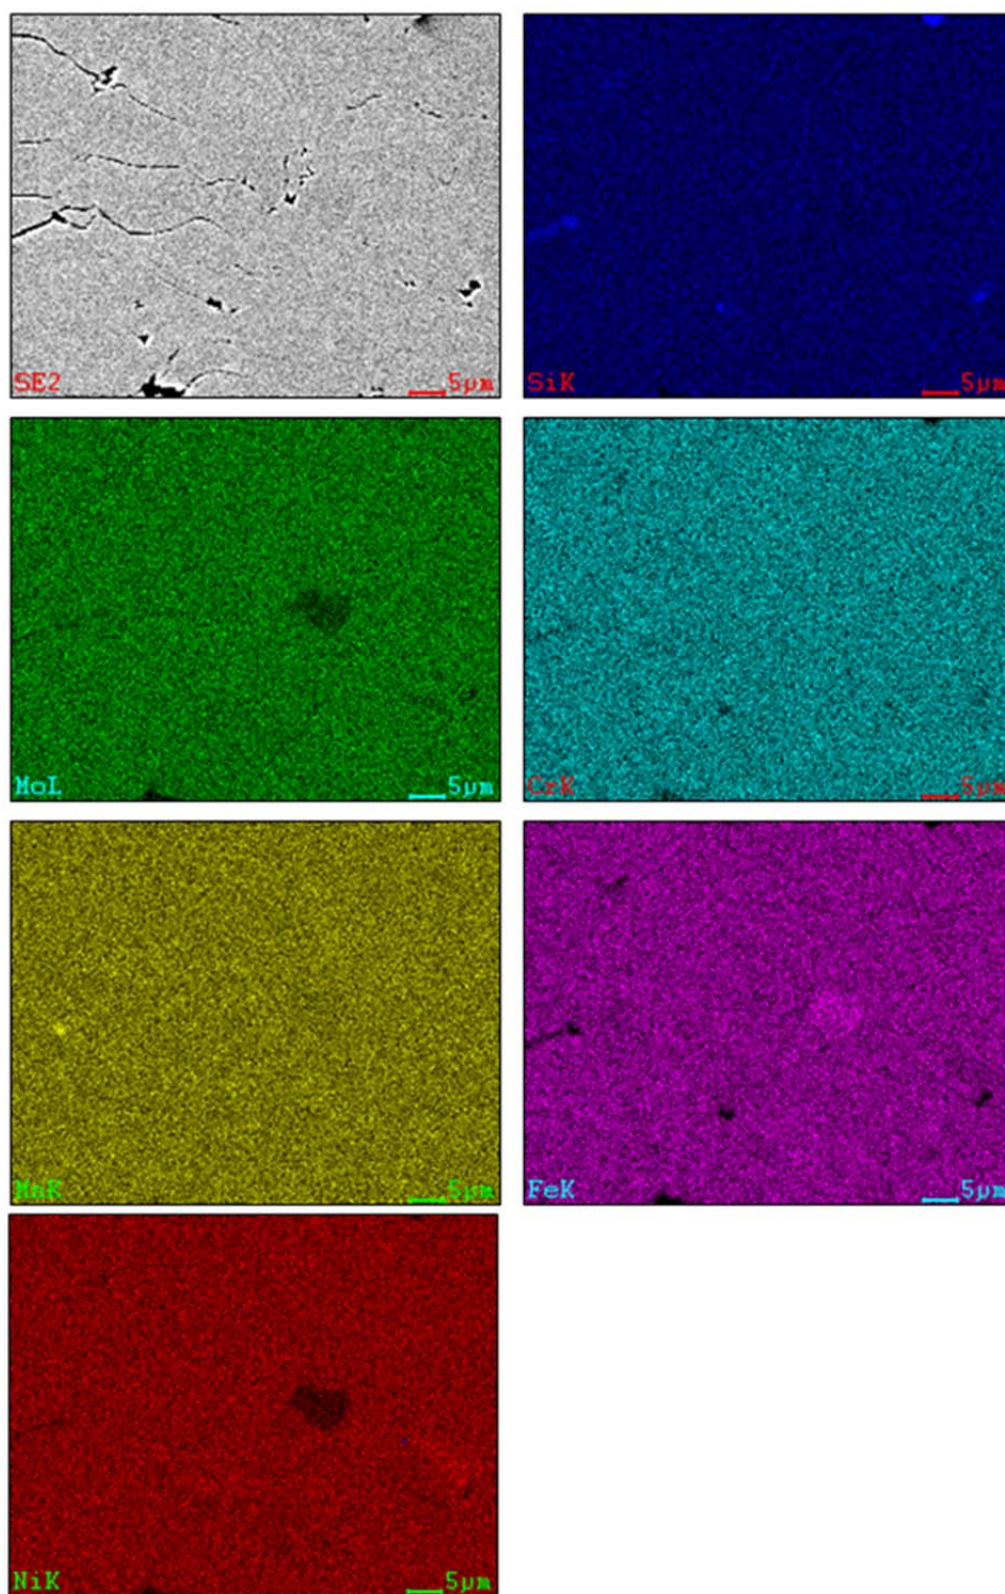
Figure 74. EDS Maps of as sprayed 5002 powder.

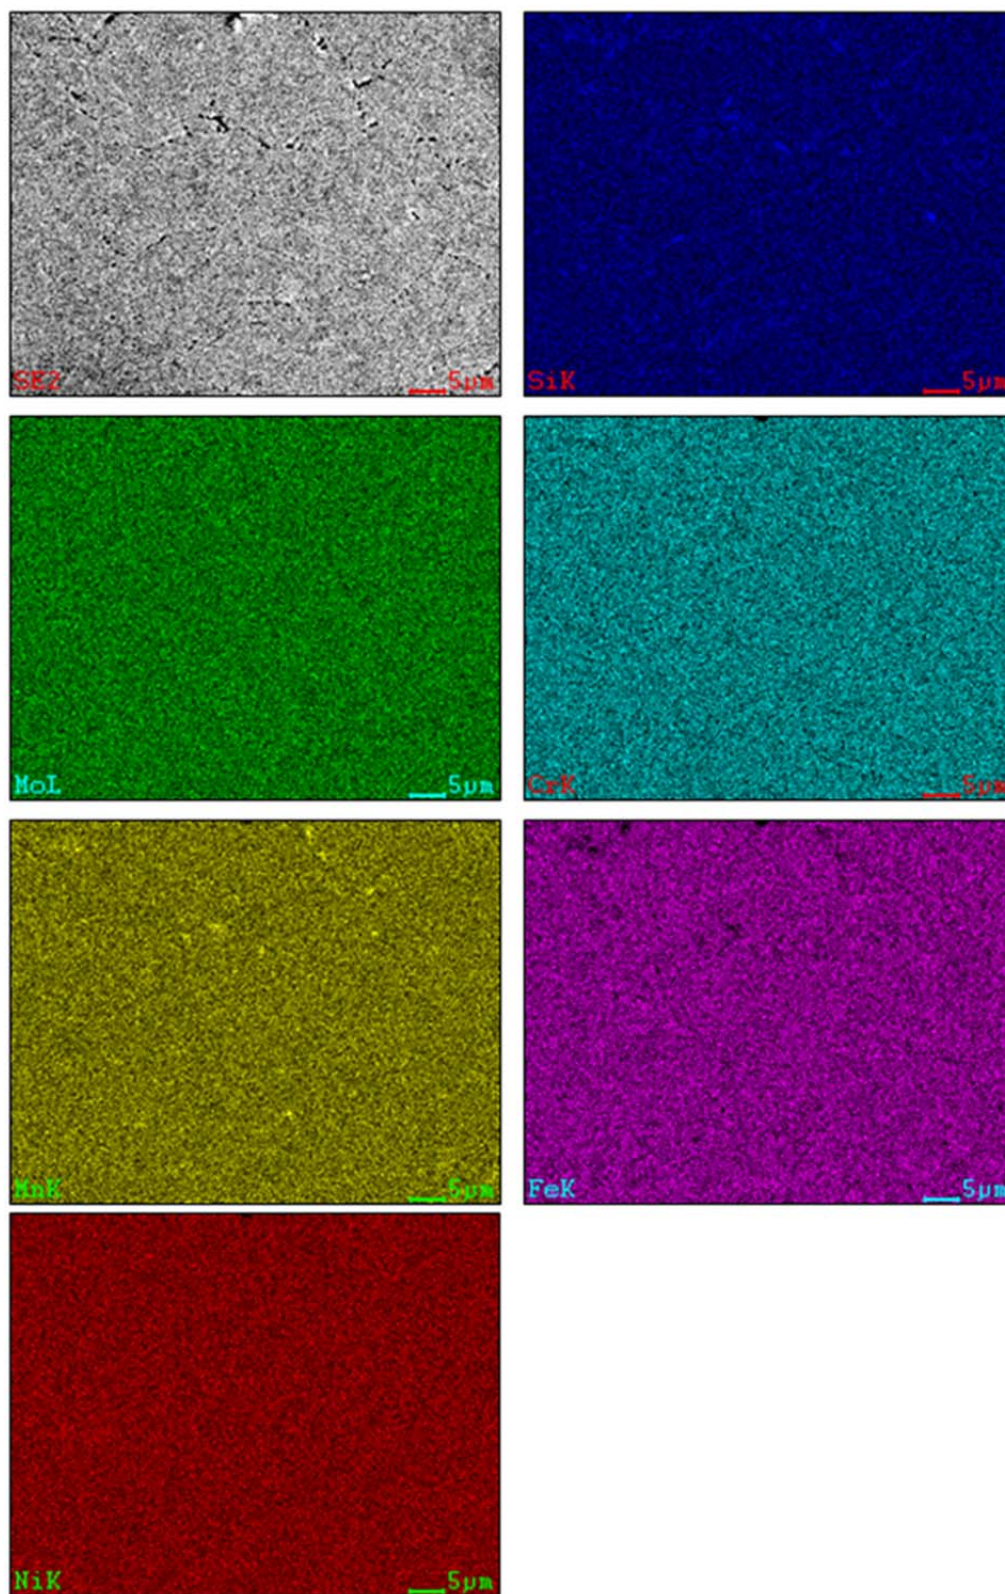
Figure 75. EDS Maps of 5002 powder, 950°C/1 hr heat treatment.

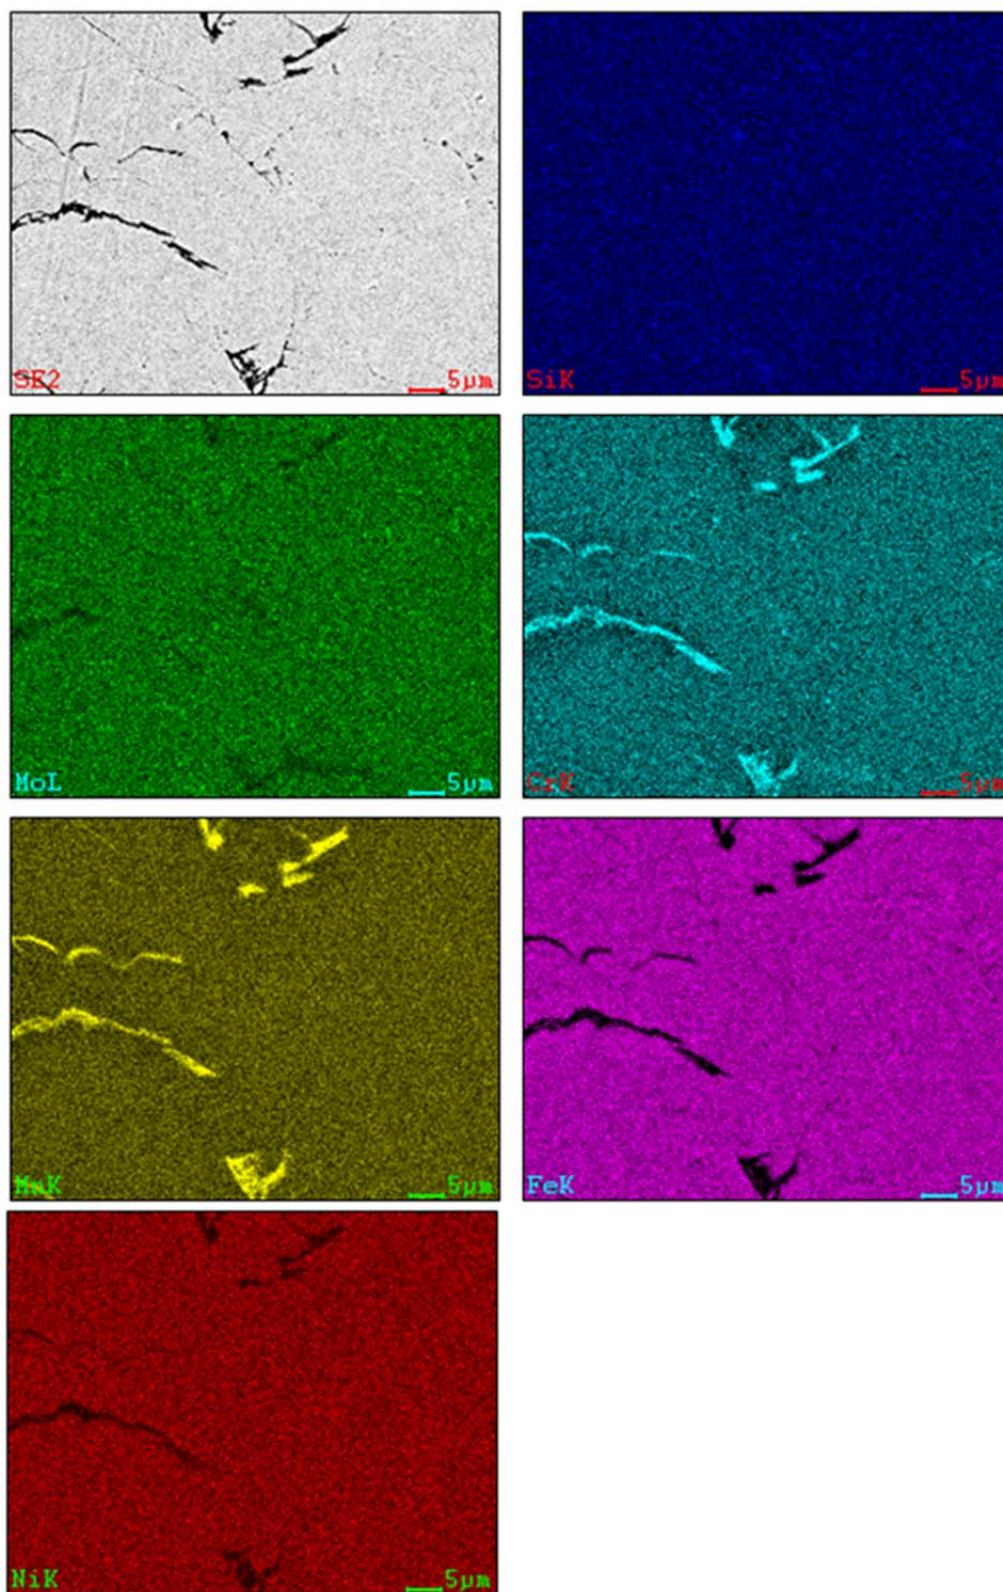
Figure 76. EDS Maps of 5002 powder, 800°C/2 hrs heat treatment.

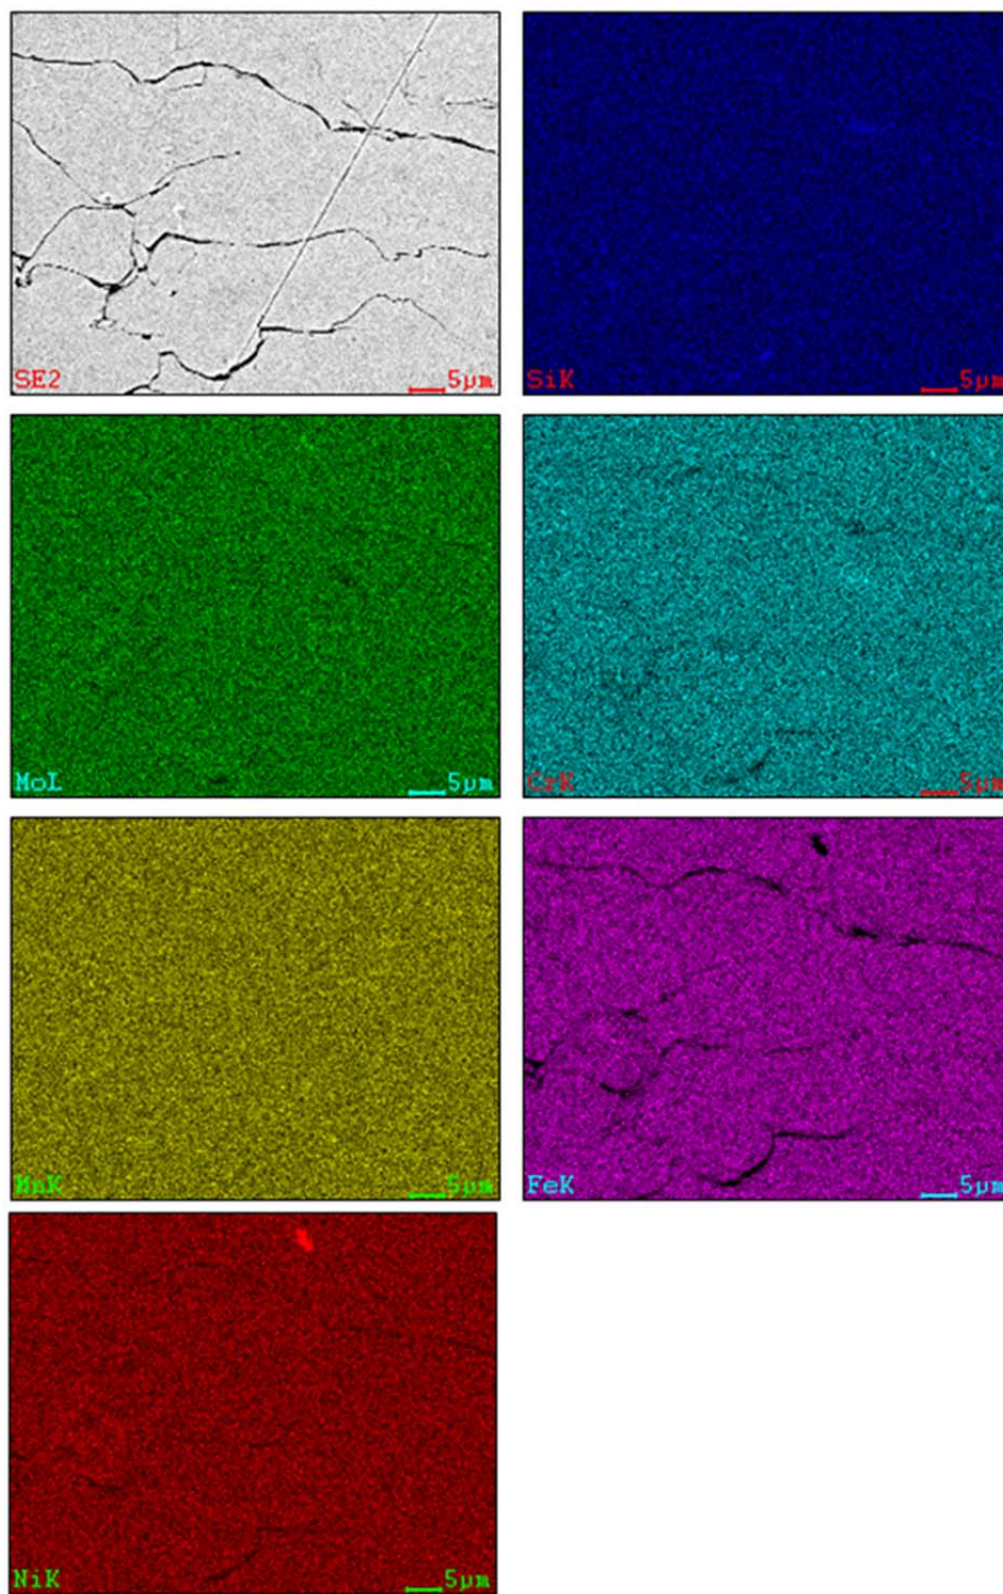
Figure 77. EDS Maps of 5002 powder, 600°C/8 hrs heat treatment.
